EXPERIMENTAL INVESTIGATION OF AIR-COOLED TURBINE BLADES  
IN TURBOJET ENGINE

XIII - ENDURANCE EVALUATION OF SEVERAL PROTECTIVE  
COATINGS APPLIED TO TURBINE BLADES OF  
NONSTRATEGIC STEELS

6817  
NACA RM E53E18

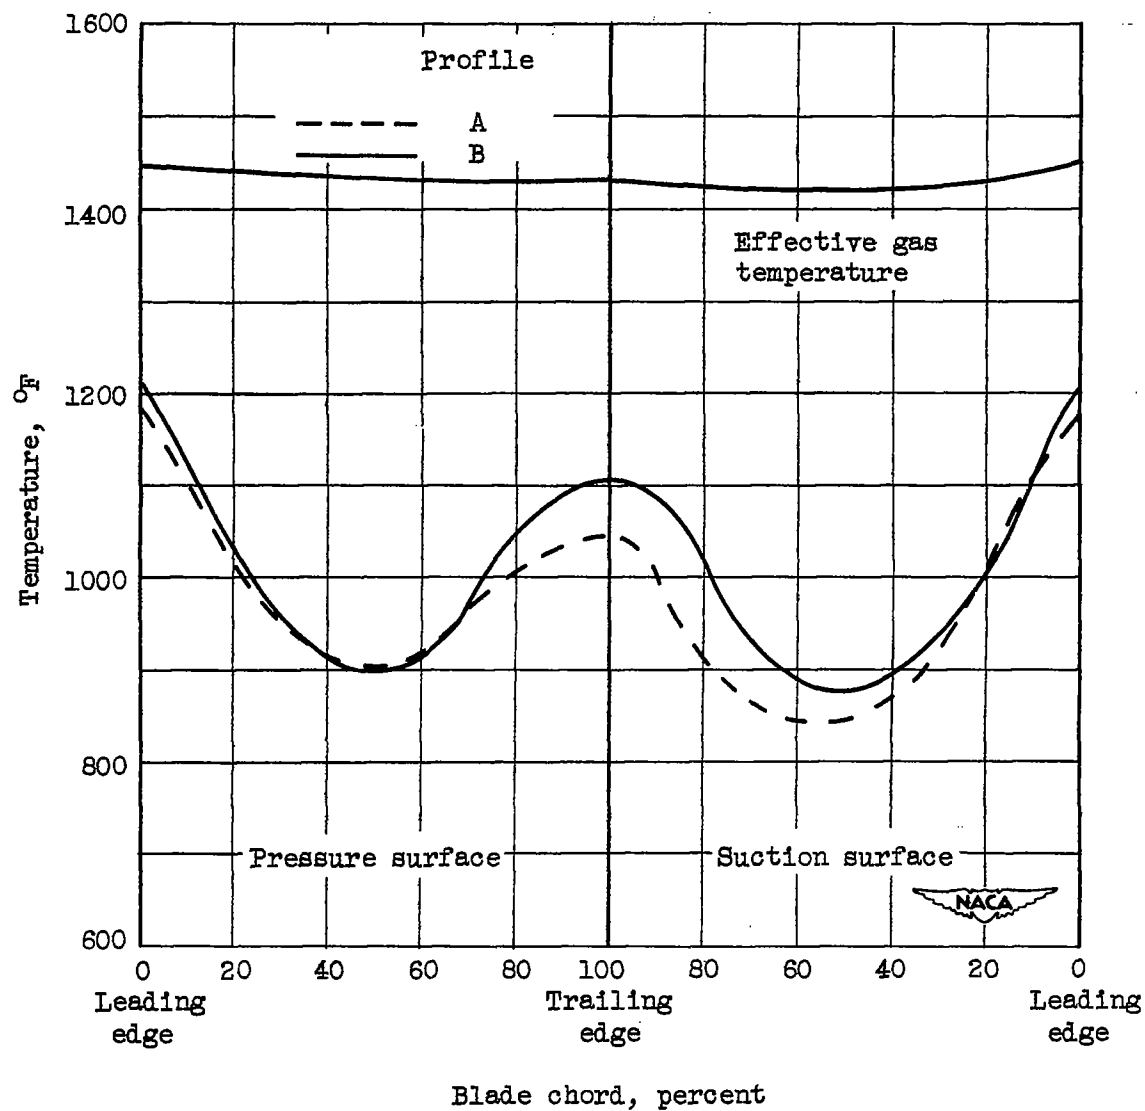
(a) Coolant-flow ratio, 0.03.

Although the metal shell of an air-cooled turbine blade is considerably cooler than the combustion gas, the temperature level is still relatively high. Experimental chordwise temperature distributions in the shells of air-cooled turbine blades of profiles A and B (see fig. 1) for coolant-flow ratios of 0.05 and 0.03 are shown in figure 2. Although these temperature distributions were obtained for specific air-cooled blades operating in a particular turbojet engine, they are indicative of the temperature levels at which metals and coatings for forced-convection air-cooled turbine blades might operate in present-day turbojet engines. It may be seen that leading and trailing edges operate at temperatures as high as 1200° F, while the midchord regions are 200° to 300° F cooler.

the blade where the coating flaked off. The failure of the coating apparently was a function of the metal temperature, as the greatest damage to the coating occurred at the leading- and trailing-edge regions where the metal temperatures are the highest (see fig. 2). More coating was removed from the leading edge than from the trailing edge, probably because the high-velocity combustion gases impinge directly upon the leading edge and their erosive action is greatest in this area.

Figure 2. - Peripheral temperature distribution at section  $2\frac{9}{16}$  inches from tip for blades of profiles A and B.

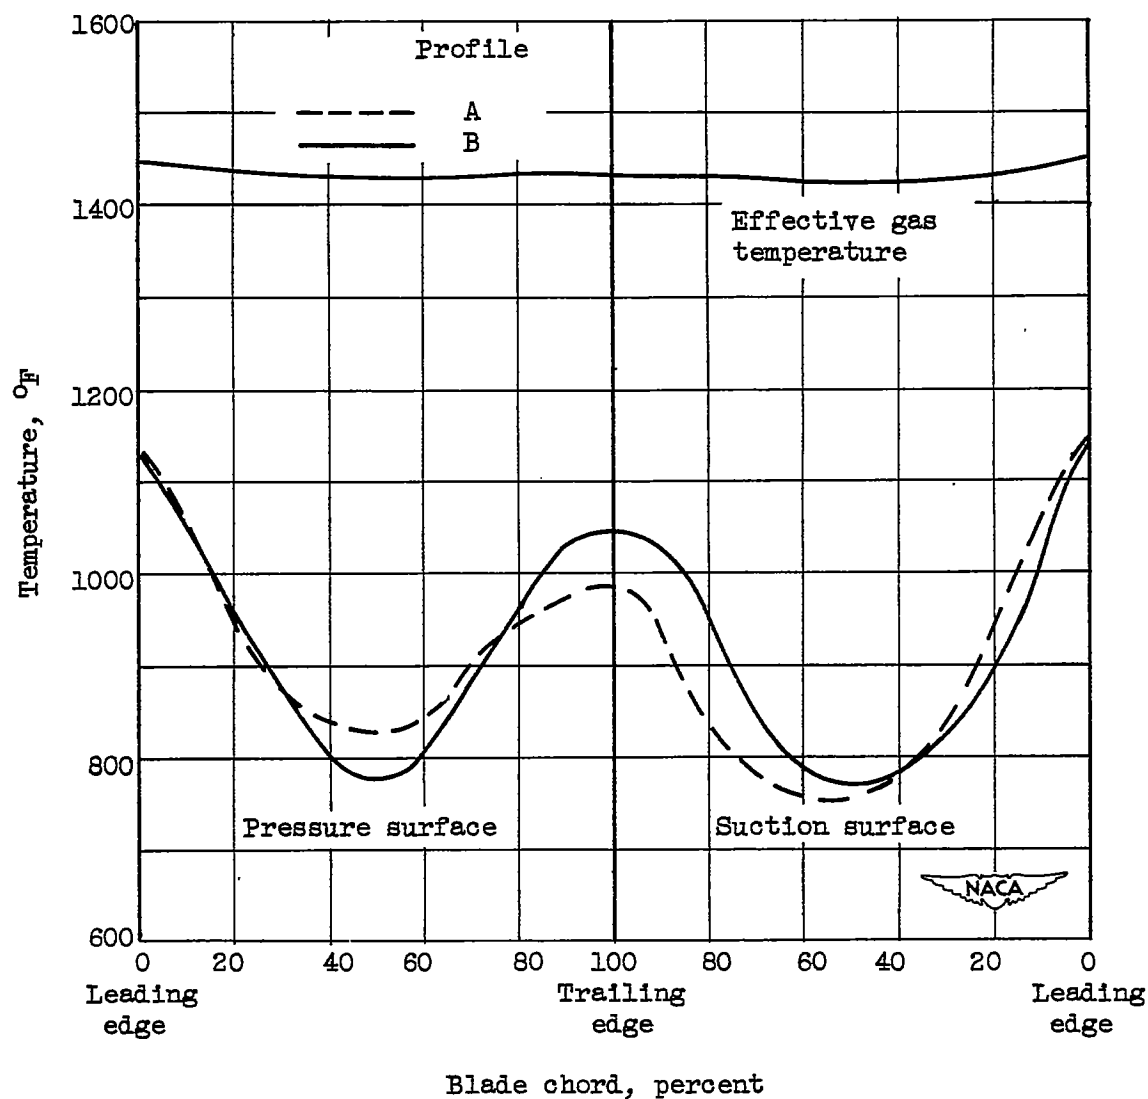
(b) Coolant-flow ratio, 0.05.

Figure 2. - Concluded. Peripheral temperature distribution at section  $2\frac{9}{16}$  inches from tip for blades of profiles A and B.
